2014 Murrells Inlet Watershed Plan

A Community-Based Management Plan to Address Fecal Coliform Impairments in Local Shellfish Harvesting Areas

Funded by USEPA Section 319 and 604(b) Grants through SC DHEC Submitted to SC DHEC by the Waccamaw Regional Council of Governments. This page has been left blank intentionally

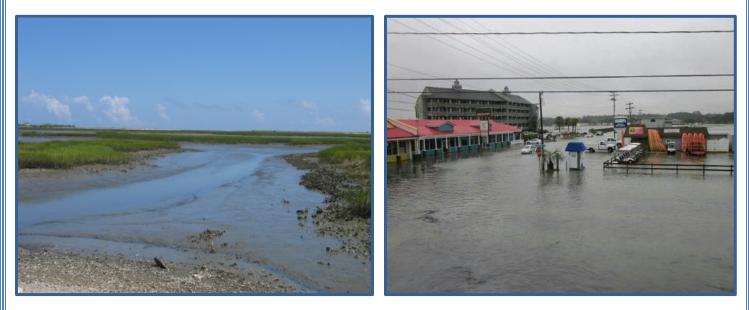
Figures A-8 and A-9 The Murrells Inlet is a very dynamic estuary system as displayed by the lowtide conditions in picture on left and the extreme high tide flooding conditions that occasionally occurs in Garden City Beach and other areas of the watershed seen in picture on the right. (Photos courtesy of Murrells Inlet 2020) This page has been left blank intentionally

Based on NOAA tidal information and LiDAR data indicating total estuary land area and channel depth, it is estimated that the diurnal tide causes approximately 2.8 billion gallons of sea water to enter and leave the inlet every 12.5 hours. This tidallydriven exchange of clean sea water provides a constant flushing effect on the inlet and the oyster beds. This effect is most pronounced in the deeper areas in the central portion of the inlet. As a result, these areas consistently meet the shellfish water quality standards. The cleansing effect of this tidal water exchange is naturally less pronounced at the extreme north and south ends of the inlet and near the shorelines. In these areas, the tidal exchange becomes more limited, due in part to sedimentation and siltation. Additionally, stormwater containing bacteria runs off the land and into the shallower portions of the inlet where less tidal flushing occurs to dilute and kill incoming bacteria. This results in higher bacteria levels in these shallower portions of the inlet.

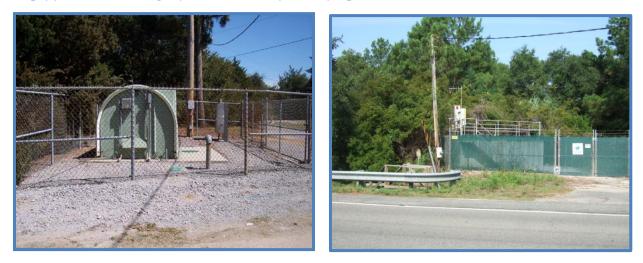
Figures C-2 and C-3: Examples of pump stations in Murrells Inlet. The pump station on the left is located near the Point Drive Canal volunteer monitoring station and the one on the right is located near the BHR volunteer monitoring station (Photos courtesy of Dan Newquist, Waccamaw Regional COG and Dr. Dan Hitchcock, Clemson University).

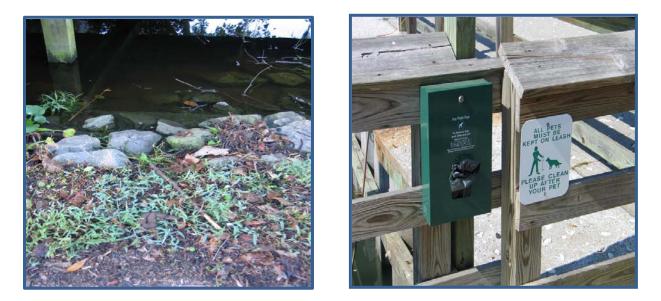
Figures C-4 and C-5: While efforts have been made to educate the public on the need to pick up pet waste, problems continue to be observed even near shoreline areas. Proper pet waste disposal needs to continue to be a priority in the Murrells Inlet community. (Photos courtesy of Murrells Inlet 2020)

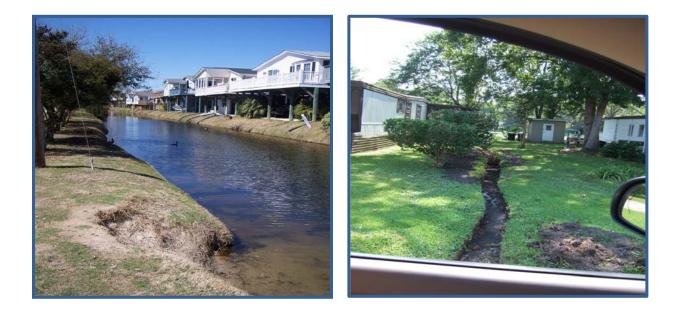
Figures C-11 and C-12: The stormwater infrastructure system within the watershed consists of an extensive network of canals, ditches, ponds, pipes, and outfalls. In some cases, residents have attempted to address localized drainage issues by constructing small scale ditches. These practices can exacerbate erosion problems and potentially affect drainage patterns in downstream areas nearby. (Photos Courtesy of Dan Newquist, Waccamaw Regional COG and Dr. Dan Hitchcock, Clemson University)

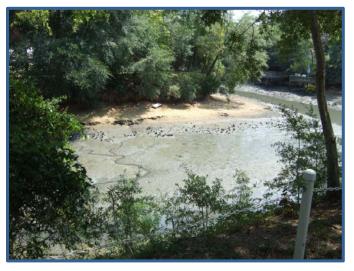
Figures C-13: Substantial sedimentation has been observed in several upstream creeks and tributaries, as evidenced in this segment of Point Dr. Canal. (Photo courtesy of Dr. Dan Hitchcock, Clemson University)

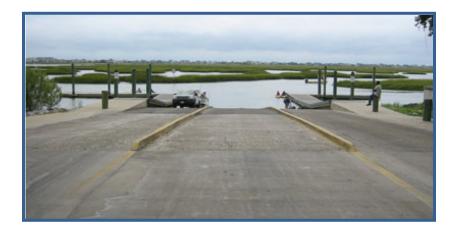
Figure C-14: Murrells Inlet is one of the most popular boating destinations in the state. Boat landings can serve as good locations for public education signage regarding water quality, shellfish habitat and boating related issues such as the impacts of boat wakes. (Photo courtesy of SC DNR)

One of the consensus findings of the steering committee is the noticeable siltation that has occurred in Murrells Inlet in recent years. One cause of the sedimentation observed in Murrells Inlet is shoreline erosion resulting from excessive boat wakes. **Element I: Public Education and Outreach Resources** is structured to prioritize public awareness strategies to specific target groups, one of them being recreational boaters. Making boat owners mindful of "No Wake Zones" is important not only for public safety and private property reasons but also to ensure that the sensitive marsh and shellfish habitats are not disturbed. It may be worth examining the appropriateness of expanding "No Wake Zones" in areas known to be experiencing pronounced shoreline erosion and siltation. The Murrells Inlet area has several public boat landings. Due to the high popularity and regular use of these amenities, they are ideal locations for interpretive signs or other public awareness tools.

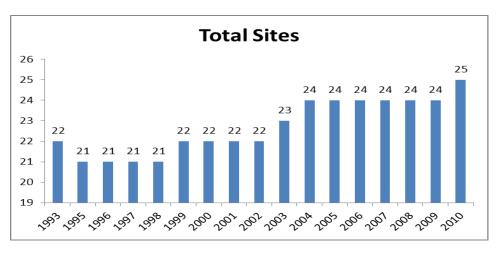
Figure D-2 Number of monitoring sites sampled by DHEC since 1993.

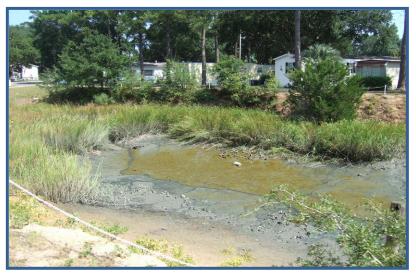
Figure D-7 Upper reaches of a tidal creek showing signs of sedimentation. (Photo courtesy of Dr. Dan Hitchcock, Clemson University).

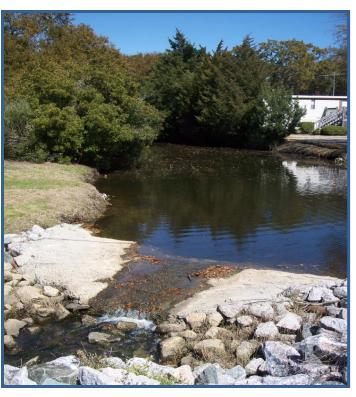
Figure D-9 Woodland Drive Pond Volunteer Monitoring Site (Photo courtesy of Daniel Newquist, Waccamaw Regional COG)

Table D-3 Murrells Inlet Volunteer Monitoring Program E. Coli (CFU/100ml) Statistics										
Site Name	Closest SC DHEC Site	# Samples	Median	Max						
Woodland Drive Pond	04-01	122	600.0	8,500.0						
Point Drive Canal	04-01	121	67.0	3,667.0						
Rum Gully Creek	04-27	120	0.0	433.0						
Marina Colony Pond	04-25	119	67.0	4,500.0						
HS	04-17A	122	800.0	9,400.0						
BHR	04-16	122	1,650.0	14,400.0						
Bike Bridge	04-07	121	200.0	5,250.0						
Oyster Landing Beach	04-08A	120	0.0	533.0						
Source: The Murrells Inlet Volunteer Monitoring Program. Data from May 20, 2008 to October 8, 2013

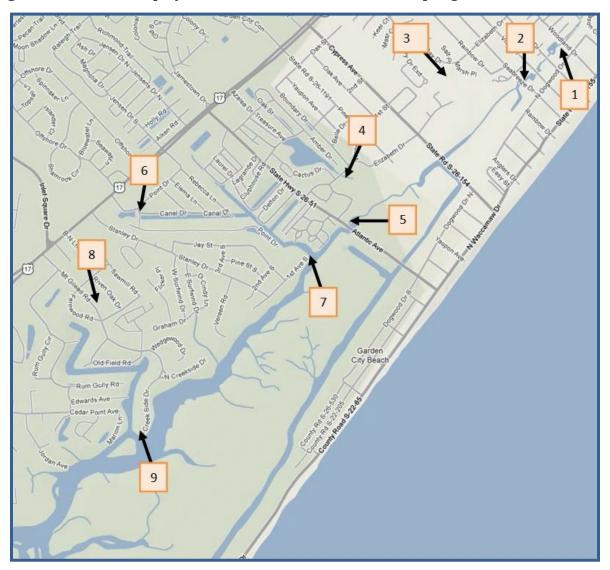
Figure D-12 below displays the locations of each of the sampling sites.

Figure D-12 Horry County microbial source tracking monitoring site locations.

- Human signals have been detected in three samples to date. One of the samples was taken near the Woodland Drive Pond Volunteer Monitoring Site. This sample also detected caffeine and optical brightener levels which are human indicator chemical tracers. The other sample was taken at SC DHEC site 04-01. Optical brightener indicators were also detected at this site. An additional sample near the Point Drive Canal Volunteer Monitoring Site also showed signals for optical brighteners and caffeine, both are indicators of human sources. These are very important initial findings regarding human contributions of pathogenic bacteria, which is necessary when investigating the extent of the problem and the remedies needed to mitigate the concern.
